## Performance of REBAM® during ball bearing failures

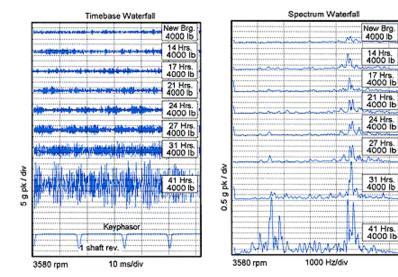
Figure 4
Axial load failure progression as seen from Accelerometer

As in the data from the radial load failure test, the data from the accelerometer during the axial load test shows excitation of structural resonances. Figure 4 shows the axial load failure progression as seen on the accelerometer. After 31 hours of testing, the accelerometer base loosened, so the data was therefore invalid between 31 hours and 41 hours. The Spectrum Waterfall plot in Figure 4 shows that the majority of the vibration energy is in two regions: one centered near 1450 Hz and the other near 4500 Hz. There is very little vibration down in the vicinity of the element pass frequencies. As in the radial load test, vibration energy at these lower frequencies was likely lost below the noise level of the accelerometer signal.

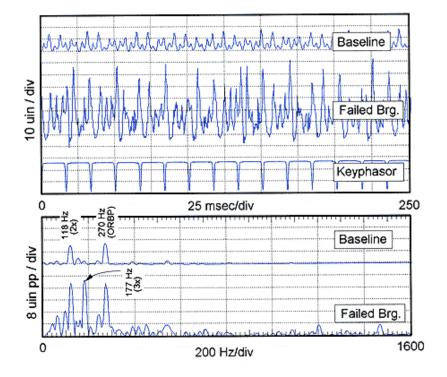
damaged from the axial load failure test, was placed under 300 pounds (1.33 kN) of axial load, and the signals were compared to those on a new bearing under the same loading. Figure 5 shows the results in the Channel 1 REBAM® signal. It is clear that the outer race element pass component does not dominate the signal to the degree that it does under high axial load. The unfiltered amplitude of the signal increased from about 17 to 70 µin peakto-peak (pp) (0.43 to 1.8 μm pp), a 310 percent increase. The Channel 1 signal filtered to the Rotor Frequency Region increased from 7 to 40  $\mu$ in pp (0.18 to 1.0 μm pp), a 470 percent increase. The Prime Spike filtered region showed a 250 percent increase from 10 to 35  $\mu$ in pp (0.25 to 0.89  $\mu$ m pp).

Figure 5 Baseline and failed bearing data under 300 lbs (1.33 kN) axial load as seen from Channel 1 REBAM® probe
